Piper Aircraft, Inc.
2926 Piper Drive
Vero Beach, FL, U.S.A. 32960

SERVICE NO. 1161D BULLETIN

**RIB ASSEMBLY INSPECTION AND MODIFICATION
– FORWARD AND AFT WING RIBS, WS 49.25**

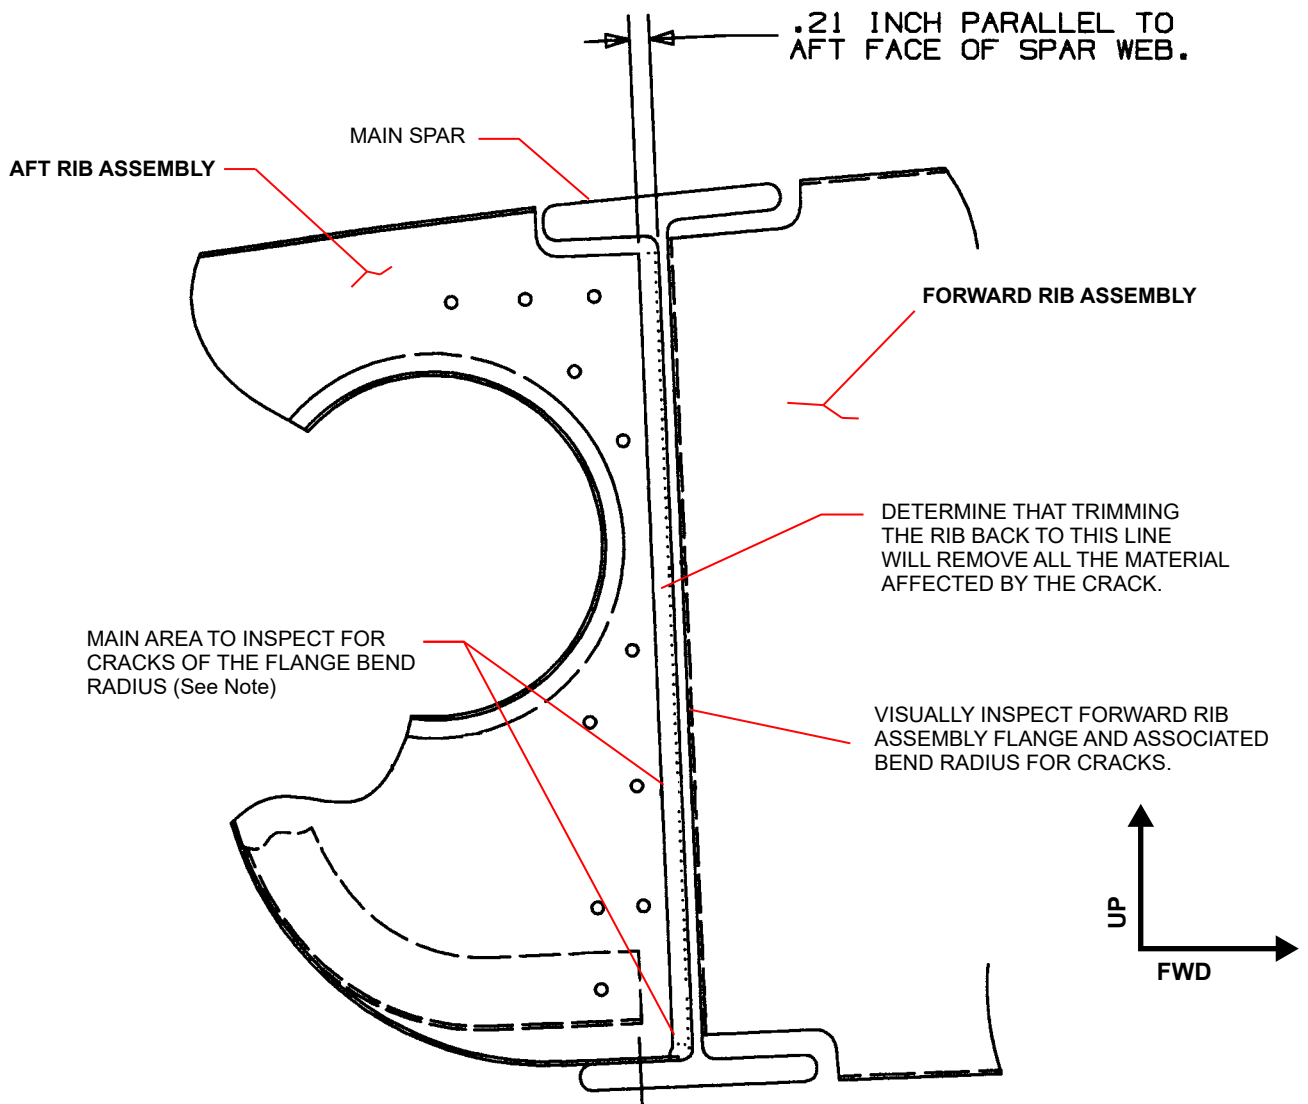
LOOKING OUTBOARD AT LEFT WING, WS 49.25
(RIGHT WING OPPOSITE)

Under certain conditions, the rib assemblies on the forward and aft side of the main wing spar at wing station (WS) 49.25 may develop a crack, located vertically along the bend radius of the flange common to the main wing spar and the side brace attach fitting.

A crack in the wing rib assembly as described, if not repaired, could compromise the ability of the rib to support the spar web and carry torsional shear loads, thereby reducing the shear buckling capability of the spar web and torsional strength of the wing.

3. Inspect the aft rib assembly (LH wing and RH wing) for evidence of cracks in the bend radius of the flange common to the main spar web (as shown in Figure 1), using dye penetrant inspection techniques. Use guidance from FAA Advisory Circular AC43.13-1B.

- If a **crack is detected**, identify the path of propagation. Determine if trimming will remove all the material affected by the crack, as illustrated in Figure 1.

Figure 1
Determine if trimming will remove all material affected by cracks or damage in the aft rib assembly

- If so, then install the appropriate kit (see Material Required section of this service bulletin). Kit installation will eliminate the recurring inspection requirements mandated by Part I of this service bulletin.

- If not, then replacement of the aft rib assembly is mandated.
 - If a replacement Rib Assembly – Aft Wing – WS 49.25, P/N 78475-000 through 78475-009, is installed, this **does not relieve the recurring inspection requirements** of this service bulletin. However, the **recurring inspections as described in Part I are relieved** if the applicable kit P/N 767-397 or 767-398 is also installed, and if the kit instructions are marked drawing number 88373, revision J (or later).

- If a replacement Rib Assembly – Aft Wing – WS 49.25, P/N 78475-010 or higher, as defined in Table 1, is installed, this **relieves the recurring inspection requirements** described in Part I of this service bulletin. (Installation of either kit P/N 767-397 or 767-398 is not required, in this case.)
