Piper Aircraft, Inc.
2926 Piper Drive
Vero Beach, FL, U.S.A. 32960

SERVICE NO. 1327E LETTER

Date: May 7, 2024

WING WALK MODIFICATION AND INSPECTION

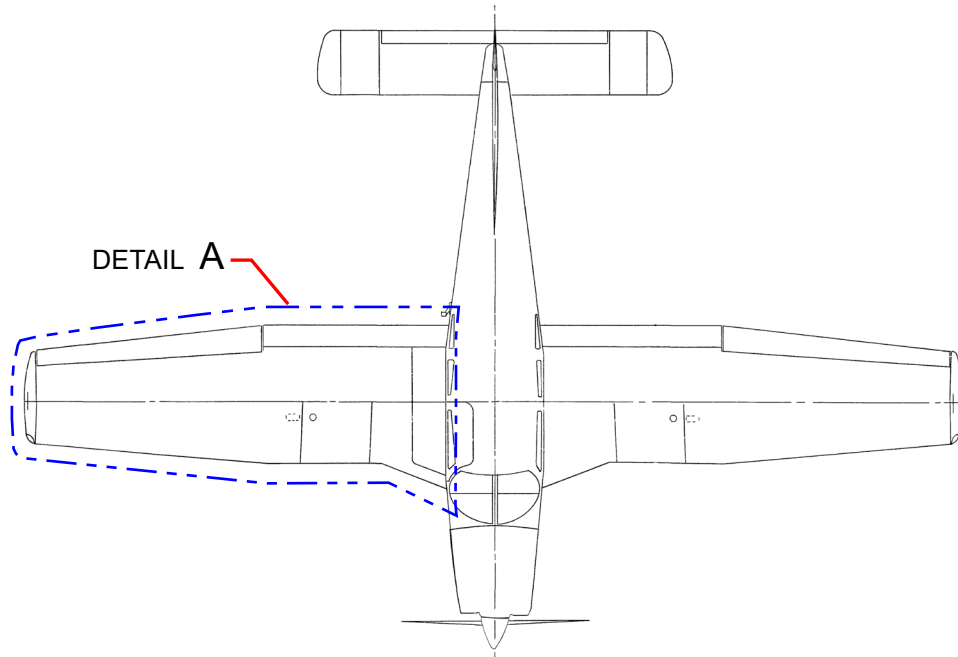
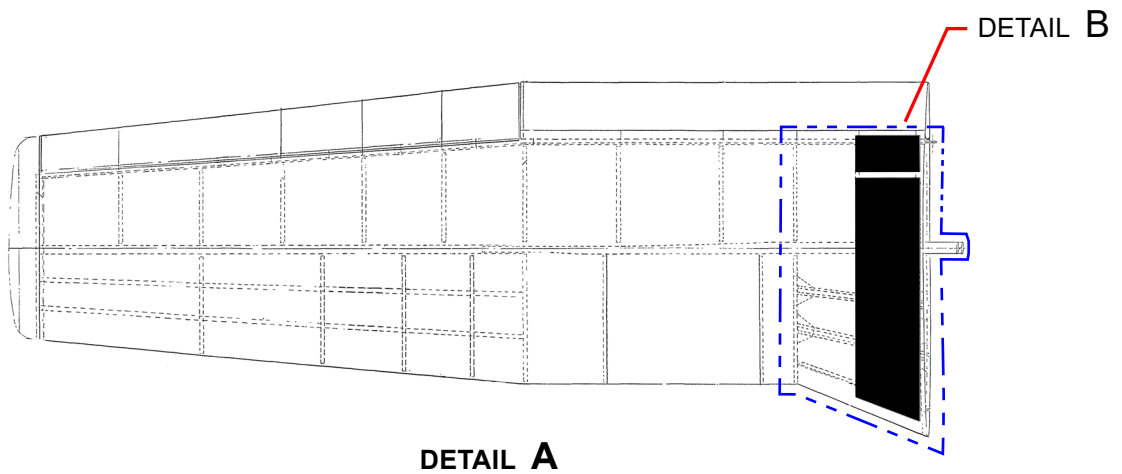
Figure 1 (Sheet 1 of 2)
Wingwalk Inspection Areas

Cracks may be discovered in the doublers (aka wing skin pan) that reinforce the wing skin, localized around the wing walkway. Aircraft with this condition are considered airworthy and may continue to operate, provided that a recurring inspection is performed on the adjacent upper wing skin. However, cracks may appear in areas normally obscured by the wing walkway material. This service letter provides a modification to the wing walkway by removing and replacing part of the wing walkway material to facilitate the required recurring inspection.

1. Locate the wing skin pan, as shown in Figure 1.
2. Inspect the pan from below for cracks.
 - If cracks are found in the pan, proceed to Part III.
 - If no cracks are found, no modification is required at this time.
 - Make a logbook entry documenting compliance with Part I of this service letter.

1. If the modification described in Part III of this service letter has not been performed, locate and inspect the pan from below for cracks, as shown in Figure 1. Otherwise, proceed to step 2.
 - If cracks are found in the wing skin pan, proceed to Part III.
 - If no cracks are found, no modification is required at this time. Proceed to step 3.
2. If the modification described in Part III has been performed on this aircraft, inspect the wing skin where the clear tape has been applied.
 - Verify there is no cracking/damage in the wing skin local to the walkway.
 - Verify there is no permanent contour deformation in the wing skin.

If cracks or other damage are discovered in the wing skin, replacement of the wing skin and doublers is required.
3. Make a logbook entry documenting the external inspection of wing walk area per Part II of this service letter.
