Piper Aircraft, Inc.
2926 Piper Drive
Vero Beach, FL, U.S.A. 32960

SERVICE NO. 1346 LETTER

MAINTENANCE ALERT

SPAR BOX INSPECTION

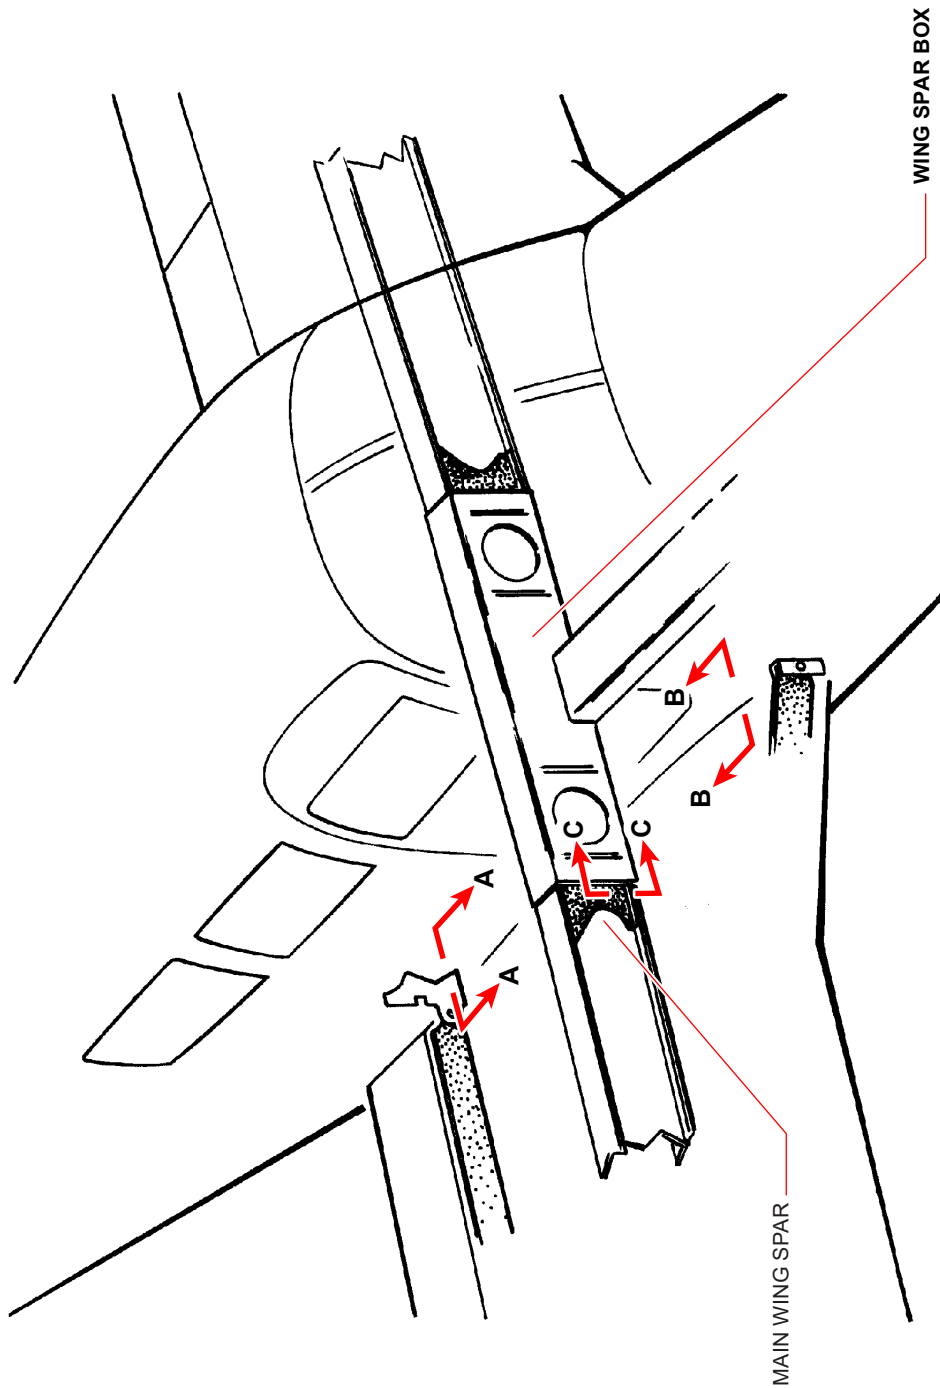
Figure 1 (Sheet 1 of 2)
Spar Box Inspection

1. For each bolt removed from the lower wing cap that secures the main wing spar to the spar box, perform the Visual Inspection method, as described page 3, on the inner surface of each spar box bolt hole for damage (scratches, gouges, thread marks, etc.). See Figure 1 for a view of the spar box and main wing spar that identifies the bolt holes and inspection areas.

MAIN WING SPAR INSTALLATION
PERSPECTIVE VIEW
(PA-28-181 SHOWN, OTHERS SIMILAR)
