**Piper**  
**Piper Aircraft, Inc.**  
2926 Piper Drive  
Vero Beach, Florida, U.S.A. 32960

**SERVICE BULLETIN No. 1123C**

**Date: May 30, 2013 (M)**

**SUBJECT: PA-34 SERIES AIRCRAFT NOSE GEAR INSPECTION AND PRODUCT IMPROVEMENTS**

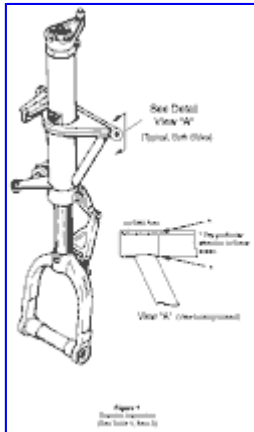
**Figure 1**  
[Trunnion Inspection](#)  
[\(See Table 1, Item 3\)](#)

3.	Visually inspect (2000 hrs. initial) the nose gear trunnion (P/N 95723-00, -05, -06) for cracks in the area of attachment to the nose gear mount assembly (See <a href="#">Figure 1</a> ) using supplemental lighting and a 10X magnifier				0

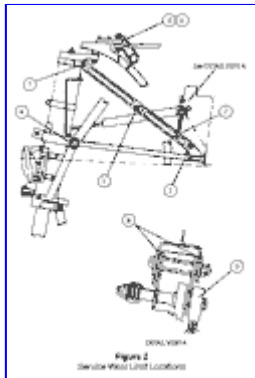
**Figure 2**  
[Service Wear Limit Locations](#)

Part Description		ID Wear Limits		Part Description		ID Wear Limits	
		Min.	Max.			Min.	Max.
1.	Drag Link Upper Bushing	0.562	0.564	6.	Steering Arm Center Pivot Sleeve	0.250	0.253
2.	Drag Link Center Bushing	0.375	0.377	7.	Down Lock Link Bushing	0.251	0.253
3.	Drag Link Lower Bushing	0.438	0.442	8.	Actuator Mount Bracket	0.250	0.252
4.	Trunnion Pivot Bushings	0.500	0.503	9.	Down Lock Link Rod End	0.190	0.192
5.	Steering Arm Center Pivot Bushings	0.375	0.377

[Table 3](#) is a "Wear Limits Chart" that can be used to determine the acceptable / or replacement condition for the listed parts that were inspected per Instructions [Step 1](#). in this Service Bulletin. Visually inspect all bolts/pins for wear, damage, or corrosion. Replace as required.
