SERVICE No. 1042 BULLETIN

SUBJECT: Inspection of the Heated Deice Panel Installation

PA-34-220T Seneca V 3449002 through 3449152

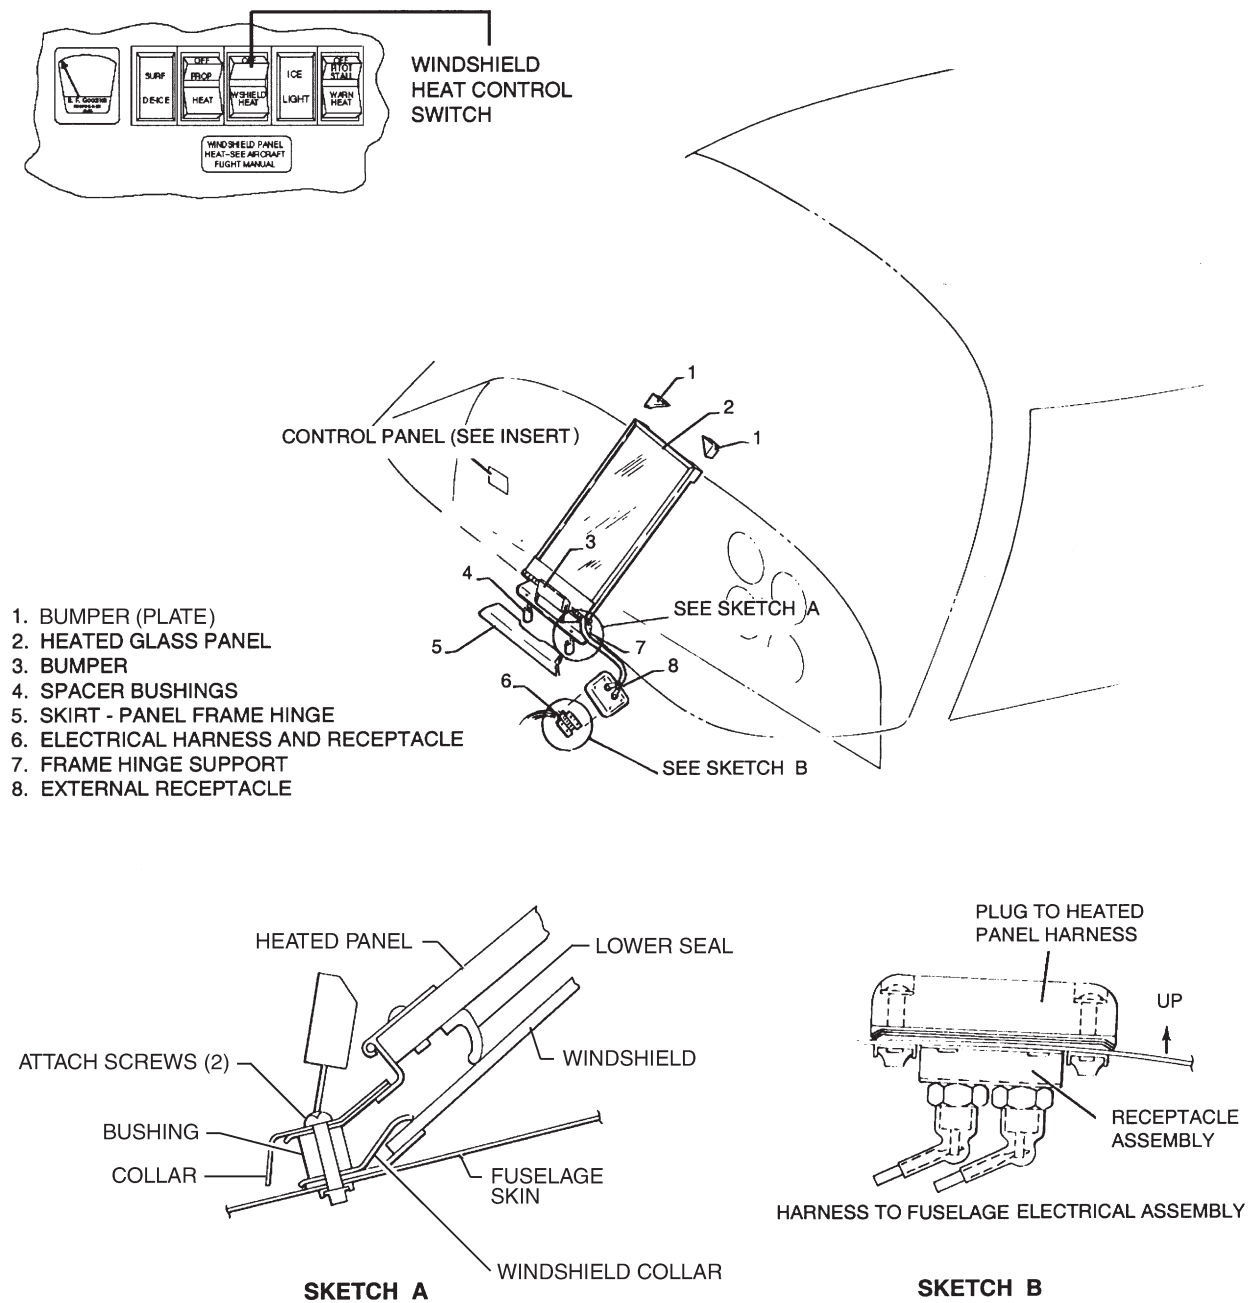
Figure 1

PURPOSE: It has been reported that during conditions of extreme snow and/or icing, the heated deice panel used for pilot's visibility may accumulate ice and/or snow under the panel such that normal operation may not provide adequate visibility. This condition is caused primarily by inadequate contact of the deice panel seals and bumpers with the pilot's windshield. The gap left by this condition allows snow and ice to accumulate between the windshield and deice panel with the resultant inability to keep the area clear. This one time inspection and, if necessary, adjustment of the heated panel, provides a remedy for this condition. Left uncorrected, should snow or ice accumulations be experienced, impaired or total loss of forward visibility may result, creating difficulties in landing and ground operations.

REFER TO FIGURE 1.

1. Inspect the Heated Deice Panel Installation to verify that the deice panel seals and bumpers are making full contact with the windshield, and that there are no gaps evident between the panel and the windshield. If any of these conditions are not satisfactory, proceed to Instruction 2.
2. Select Windshield Heat Control Switch to OFF and disengage the WSHLD HEAT circuit breaker. Remove electrical plug from receptacle assembly, if necessary.

3. Check that the seals are in good condition and fully bonded to the deice panel and that the lower and inboard seals are bonded together at the mitered corner. Seals that are in good condition but not fully bonded to the deice panel or not fully bonded together at the mitered corner may be rebonded using black RTV133, or equivalent, sealant.
4. If, after the seals are verified in good condition and properly bonded, there is still inadequate contact of the deice panel seals and bumpers with the windshield, continue with Instruction 5.

5. Adjust the deice panel so that the lower seal makes full contact with the windshield as follows:
 - (a) Remove the two MS35206-328 screws from the windshield collar and elongate the attachment holes in the deice panel to allow for more adjustment.

OR
 - (b) Trim the existing bushings as necessary and prime. After trimming the bushings, it will be necessary to file the collar on the deice panel to maintain 0.03 minimum clearance from the windshield collar.

OR
 - (c) Increase the height of the bushings by adding 0.063 aluminum washers (NAS1149DO363H).
 - (d) Install the deice panel to the windshield collar.
6. After the lower seal has been adjusted to make full contact with the windshield, insure the inboard seal makes full contact with the windshield by adjusting the upper corner bumpers as follows:

- (a) If additional height is needed for the bumpers, replace the existing bumpers with new bumpers (Piper Part Number 31637-03, length 11/16").
 - (b) If it is determined that the bumpers need to be trimmed, carefully trim as required to match the mating surface of the windshield.
7. Upon completion of adjustments:
 - (a) Be sure that the two screws that secure the deice panel to the windshield collar are sufficiently tightened.
 - (b)
