Piper Aircraft, Inc.
2926 Piper Drive
Vero Beach, FL, U.S.A. 32960

SERVICE NO. 1423A BULLETIN

Date: May 13, 2025

WING AFT SPAR-TO-FUSELAGE ATTACHMENT HARDWARE INSPECTION

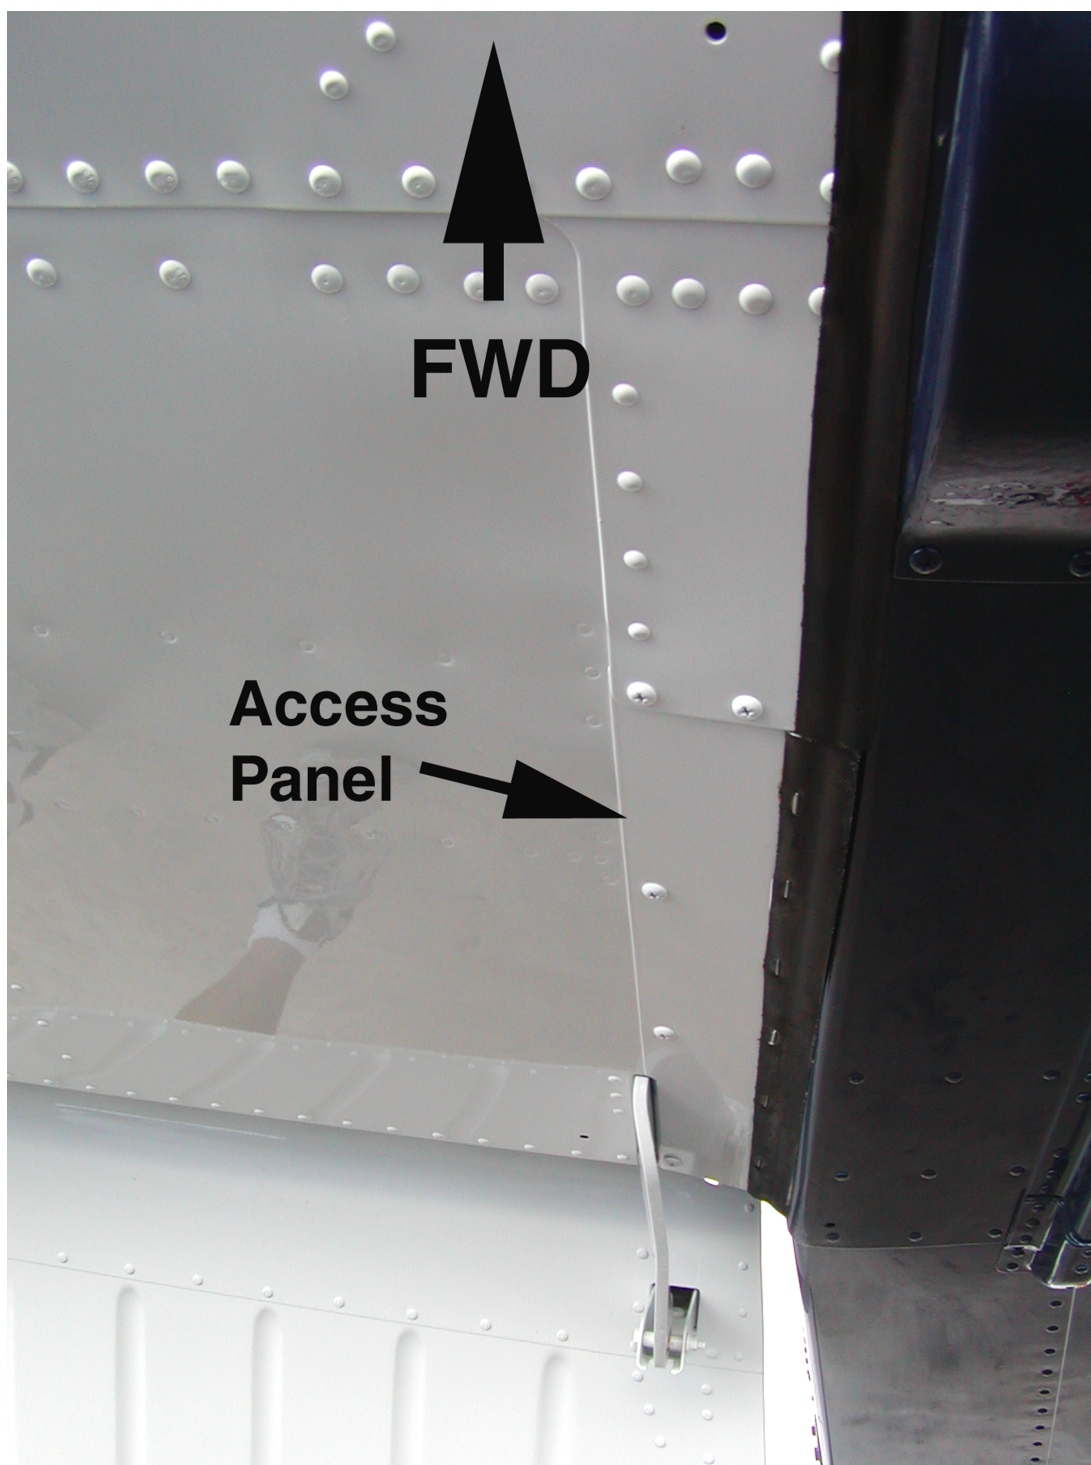
Figure 1
Typical Panel Location (Under RH Wing)

TYPICAL ACCESS PANEL LOCATION
LOOKING UP AT INBOARD
SECTION OF RH WING

1. Remove the lower wing-to-fuselage fairing in the area of the wing aft spar. See Figures 1 and 2.
2. Lower the flaps to gain access to the head of the aft wing-to-fuselage attachment bolt.
3. Examine bolt to determine the nominal diameter. Inspect the bolt in the fittings.
 - a. Verify the bolt is secured by performing one of the following actions:
 - Visually confirm the bolt head or nut has an unbroken torque stripe.
 - Perform an off-torque (i.e., loosening torque) test to confirm the bolt head does not loosen (e.g., does not rotate in the counter-clockwise direction) when the following torque value range is applied:
 - For 5/16 inch diameter bolts, off-torque value is 100–115 in-lbs minimum.
 - For 3/8 inch diameter bolts, off-torque value is 180–195 in-lbs minimum.

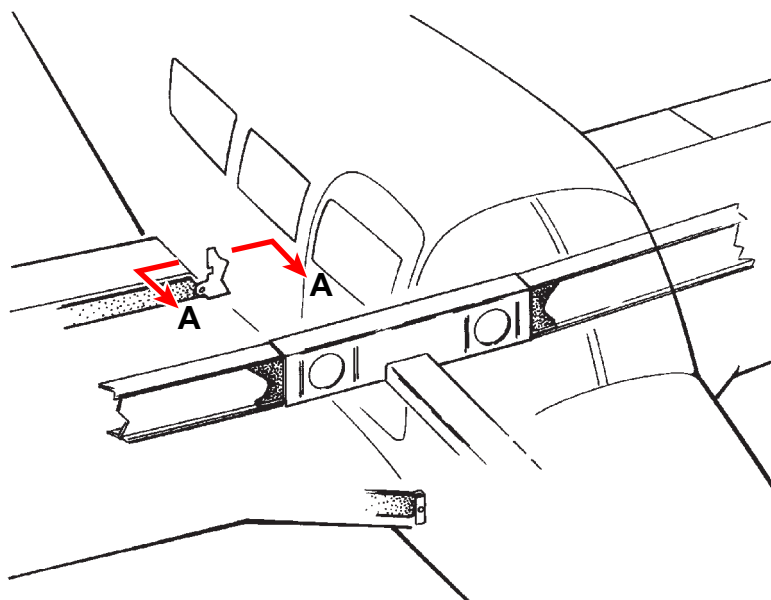
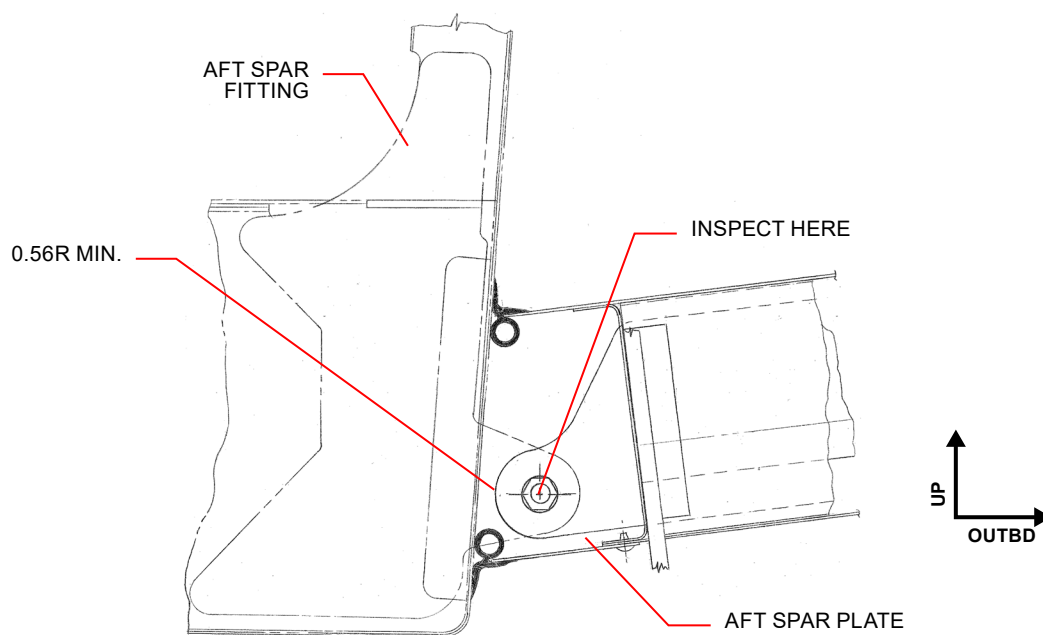
Figure 2
Wing-to-Fuselage Attachment Bolt Location

There have been isolated reports that the left hand and right hand aft wing spar-to-fuselage attachment nut and bolt have loosened. This Service Bulletin requires inspection and corrective action to prevent recurrence of the bolts loosening.

ATTACHMENT BOLT LOCATION
LOOKING DOWN AT INBOARD
SECTION OF RH WING

VIEW A-A
LOOKING FWD AT AFT SPAR ATTACHMENT
RIGHT WING SHOWN (LEFT WING OPPOSITE)

If the bolt is secured, no further action is required. Proceed to step 4.
If the bolt is not secured, further action is required. Proceed to step b.
 - b. If the bolt head or nut has a missing/broken torque stripe or the bolt fails the off-torque test described in step a, perform the following:
 - 1) Remove the attachment hardware (bolt, washer, and nut – retain/replace hardware on condition) to inspect the holes in the fittings for size and make sure no out-of-round condition exists outside of allowable limits. The specified hole size is as follows:
 - For 5/16 inch diameter bolts, the specified hole size is 0.3115–0.3135 inch diameter.
 - For 3/8 inch diameter bolts, the specified hole size is 0.3745–0.3765 inch diameter.

- 2) If the holes meet the requirements specified above, inspect gap between the fittings.
 - a) If gap is below 0.032 inches, reinstall the attachment hardware. Refer to chapter 57-40-00 of the applicable Piper AMM/SM for installation instructions. Then proceed to step 4.

- b) If gap is above 0.032 inches, but does not exceed 0.15 inches (before shimming with washers), install replacement hardware as required per Chart 1. Ensure that 1 1/2 threads of the bolt protrude from the nut. Then proceed to step 4.
